IN RE: NEW ENGLAND COMPOUNDING PHARMACY, INC. PRODUCTS LIABILITY LITIGATION

THE PLAINTIFFS' STEERING COMMITTEE'S
OPPOSITION TO LIBERTY INDUSTRIES, INC.'S OMNIBUS MOTION FOR
SUMMARY JUDGMENT IN CASES FILED BY PLAINTIFFS INJECTED IN INDIANA

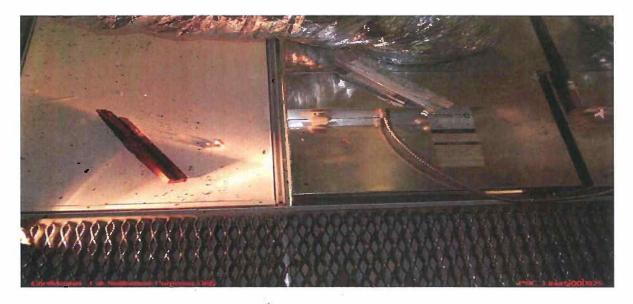
The images below, taken from on top of the 2006 Cleanroom, shows light shining from below in the cleanroom itself through significant gaps between the ceiling grid and a number of different light fixtures:
